THE CEZUS AFFAIR A flaw in the quality control of nuclear fuel tubes

Briefing CEZ1

Version 1 6 December 2000

Key words: *Generic flaw - fuel cladding - quality control - CEZUS*

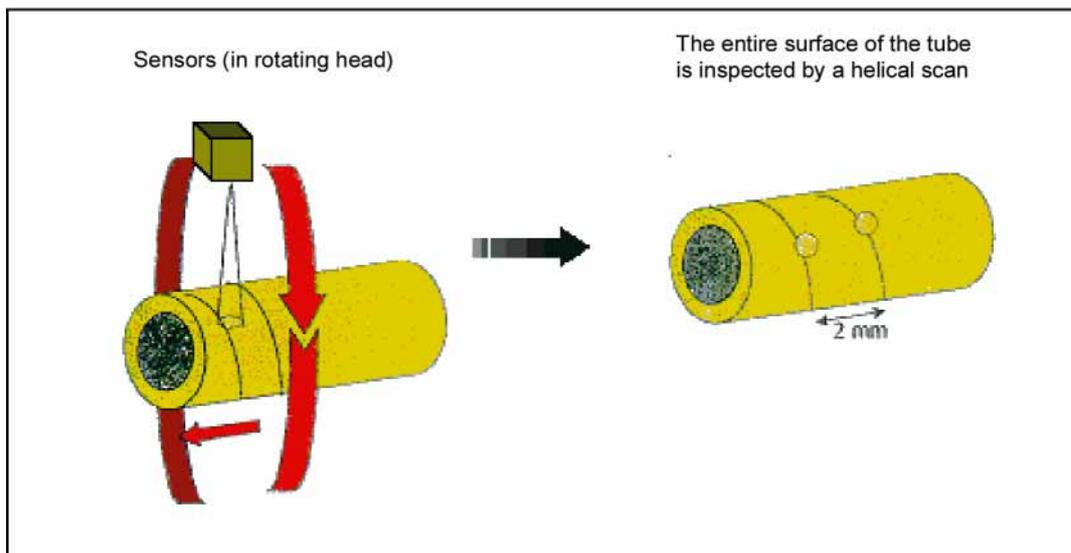
Principle : Rotation of sensors, linear movement of tube

After a maintenance operation on two of the three inspection machines used, it was found that the first tube of each batch was able to enter the inspection unit before the instruments were operating. The CEZUS/Zircotube plant corrected this problem in March 2000, without informing Framatome's national departments nor its clients.

The machines provide an ultrasonic inspection of each tube to check that the dimensions (outer diameter, inner diameter, thickness, roundness) and surface condition (no cracks) comply with the hypothetical values given in the design documents for fuel rods and in reactor safety studies.
